# School Closing Study

Mariam Boyd Elementary, Northside Elementary, and Vaughan Elementary schools

February 13, 2024

# FINANCIAL SUMMARY OF CONDITION ASSESSMENT FINDINGS

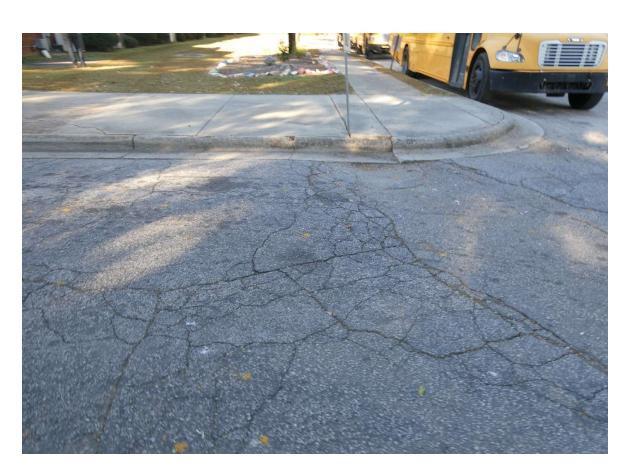
Asphalt with alligator cracking.

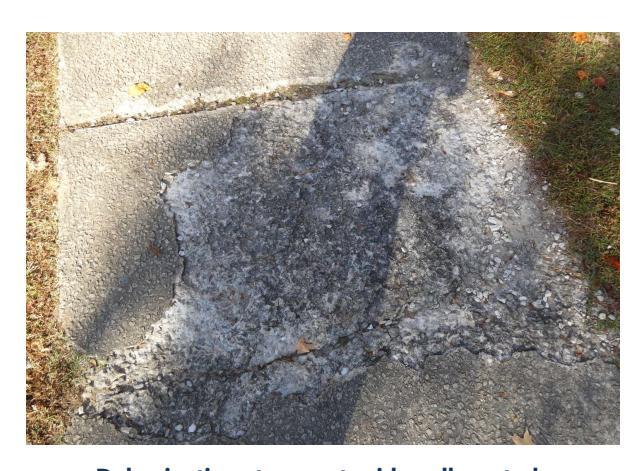
Delamination at concrete sidewalks noted.

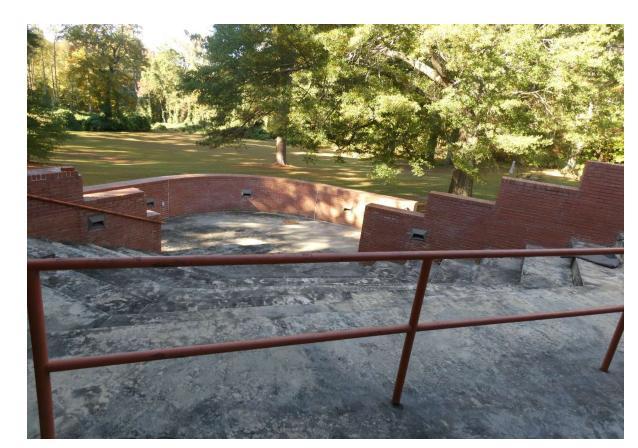
Significant settlement issues were noted at the amphitheater.

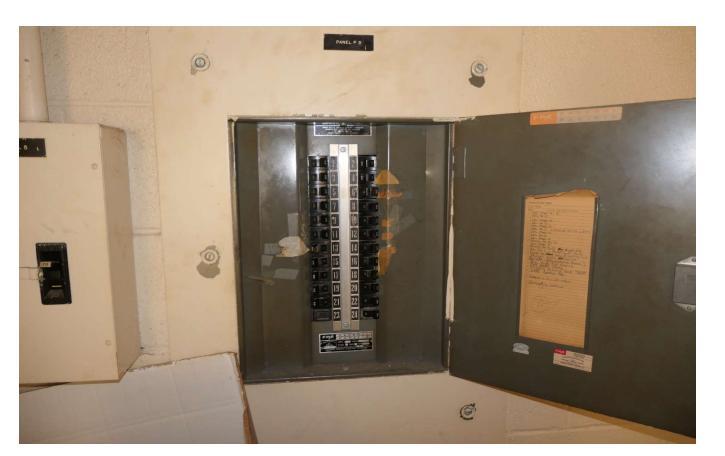
Federal Pacific electrical panels are obsolete.

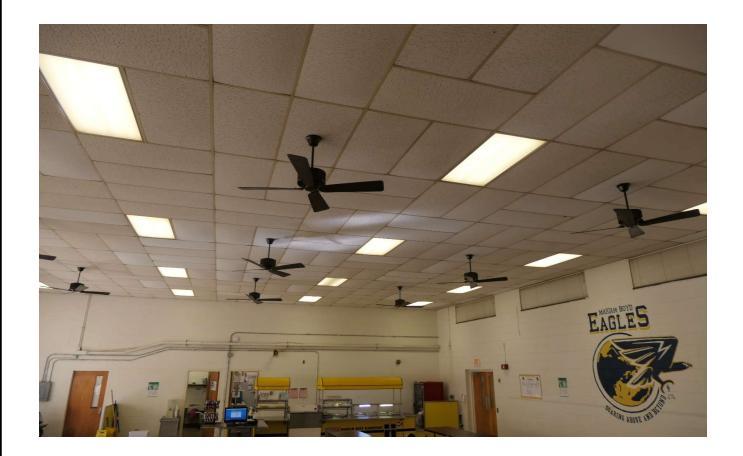
Sagging ceiling tiles often indicate potential humidity issues.

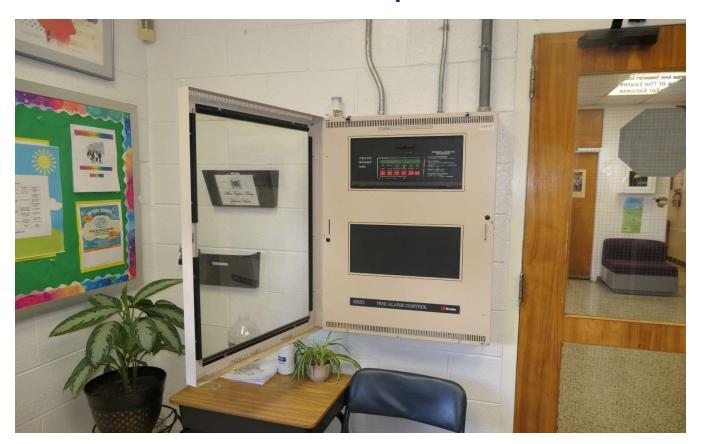
**Obsolete fire alarm control panel.**

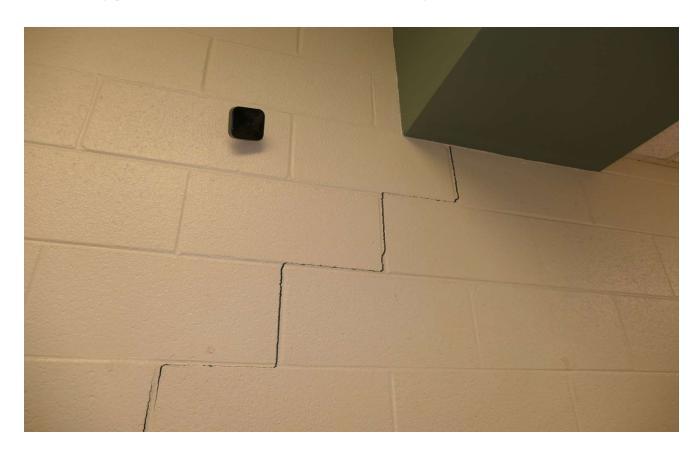
Minor stair-step cracking which should be monitored.

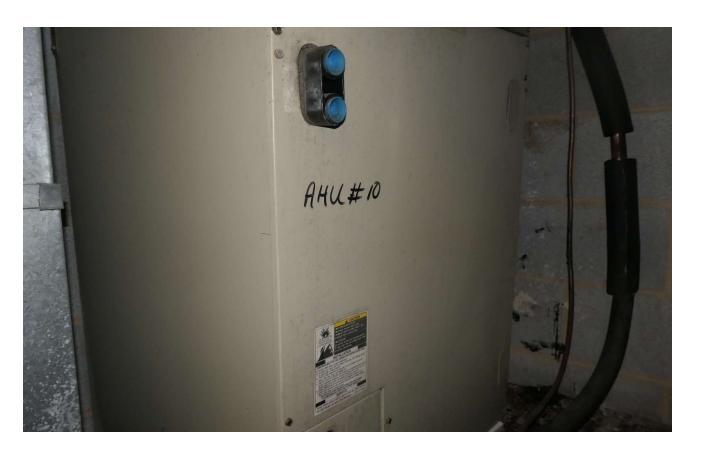
Air handling units are in poor condition.

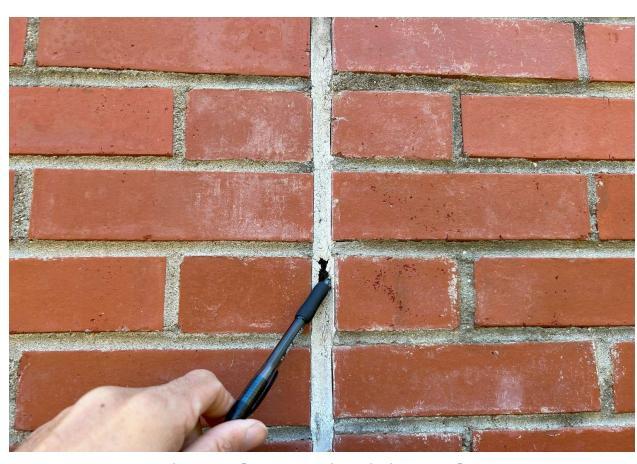
Deteriorated expansion joint sealants

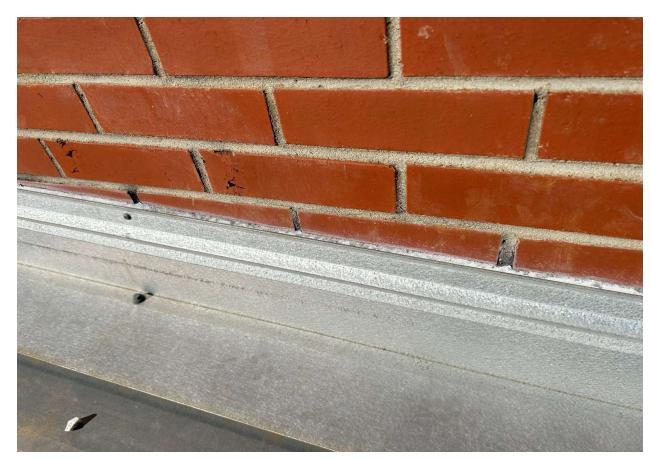
Deteriorated sealants at termination bar at roof level.

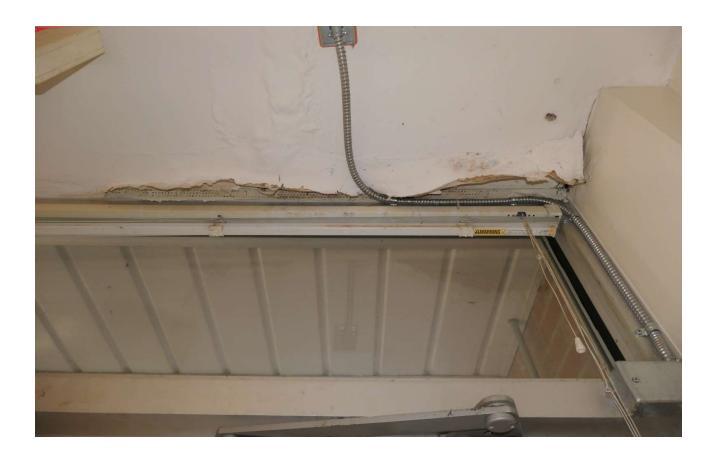
Water ingress due to poor building joint.

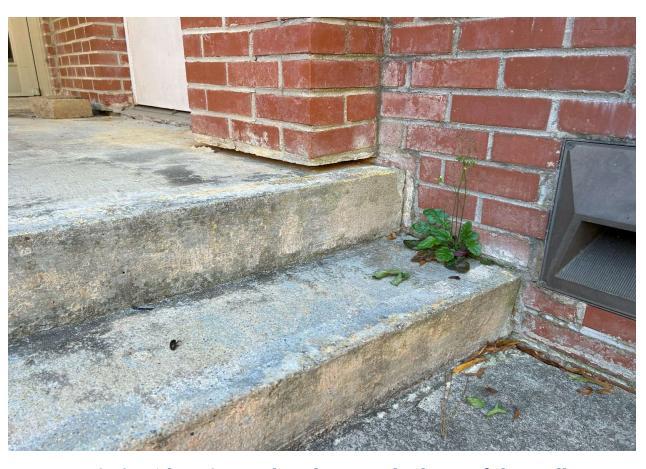
Missing/deteriorated sealants at the base of the walls.

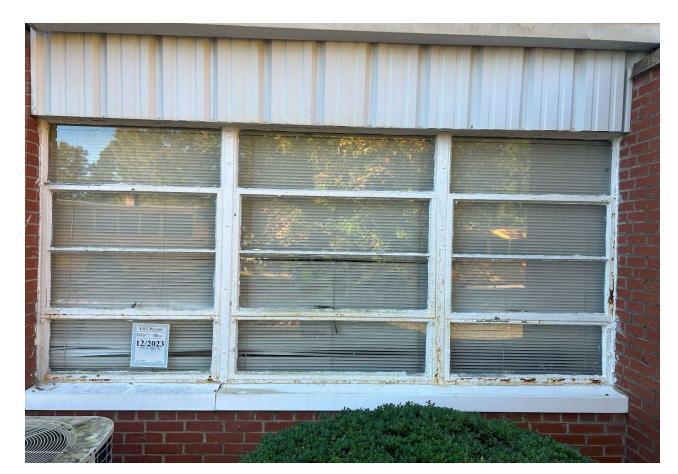
Single pane windows are in poor condition.

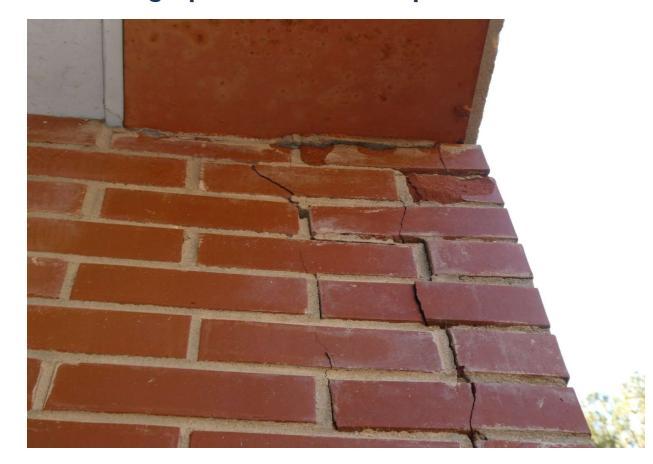
Minor cracking at the amphitheater area.

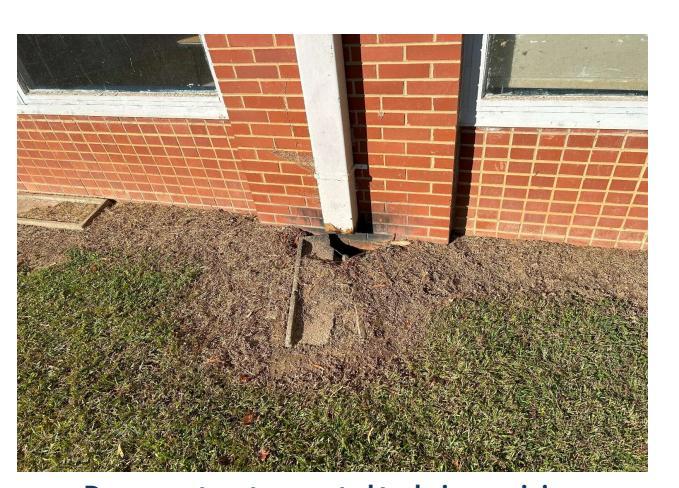
Downspouts not connected to drainage piping.

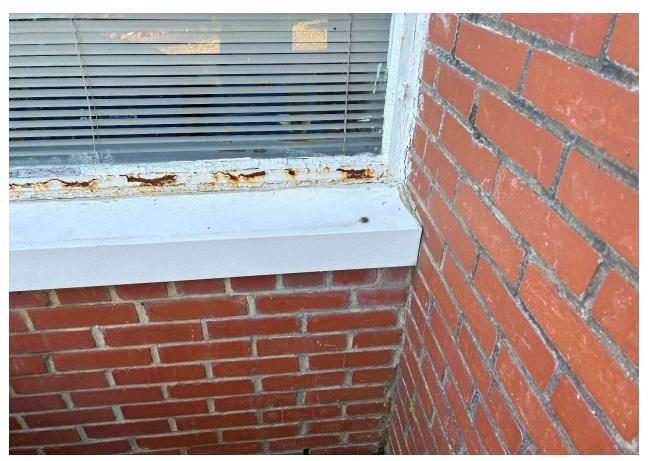
Deteriorated perimeter window sealants.

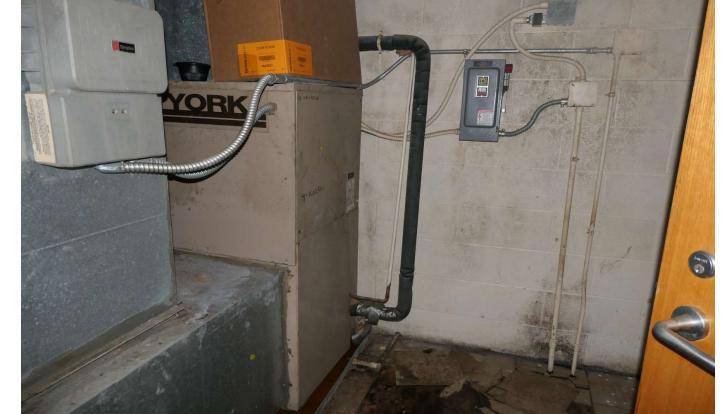
Split system unit serving cafeteria with condensate leak which damaged the stage.

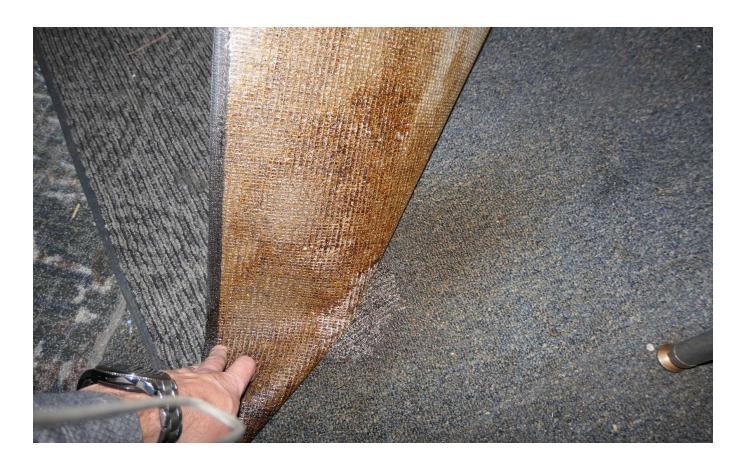
Unknown substance coming up and staining the carpet.

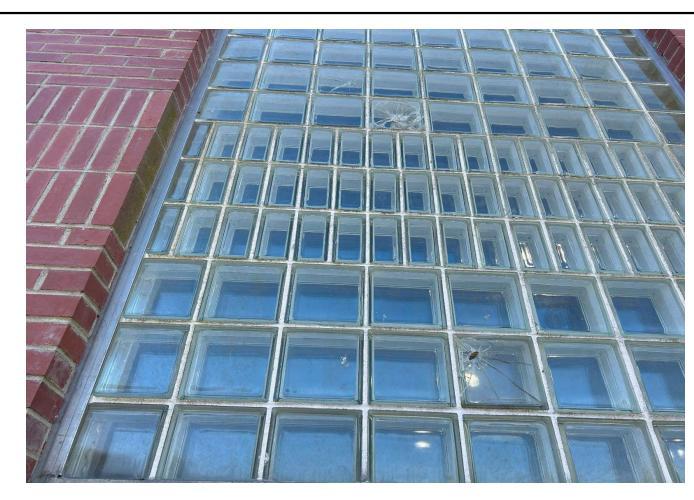
Cracked glass block.

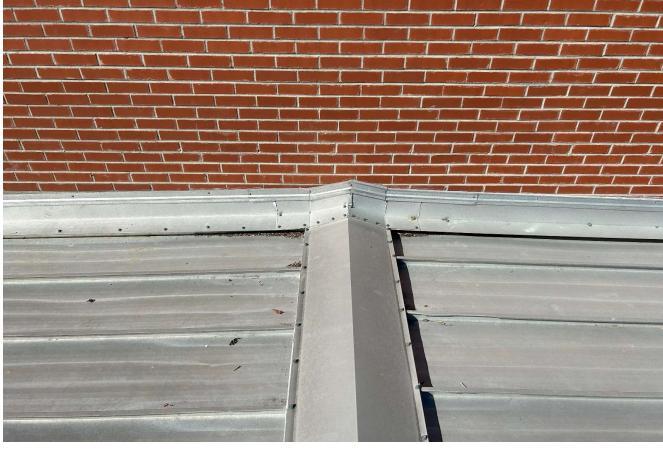
Building transitions have poor detailing.

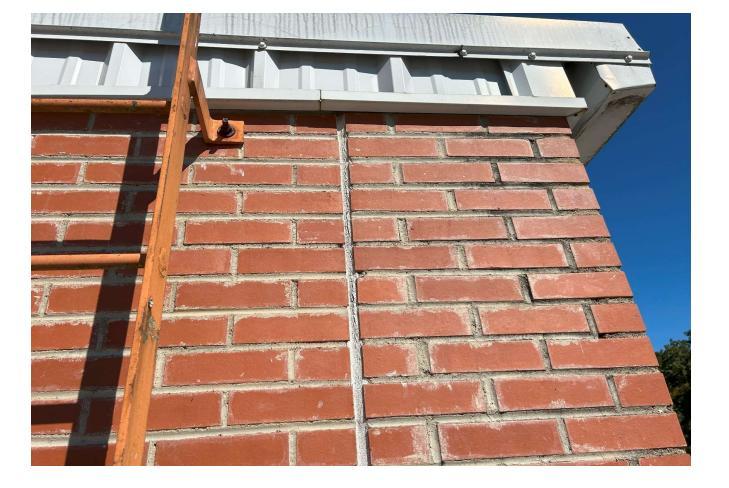
Deteriorated expansion join sealant.

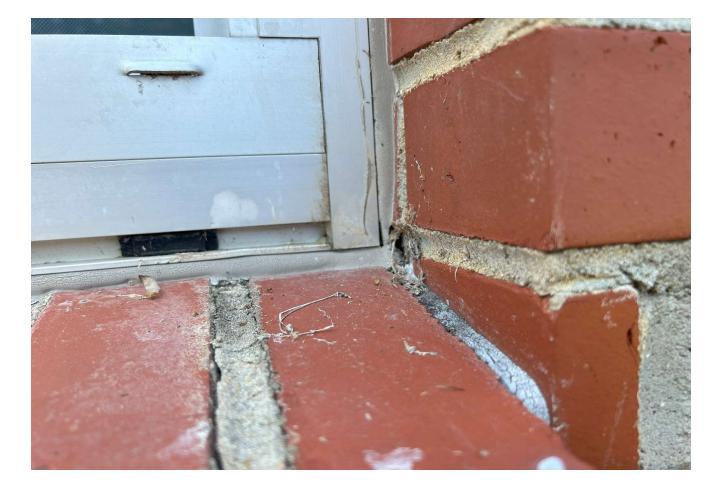
Window sealants are in poor condition.

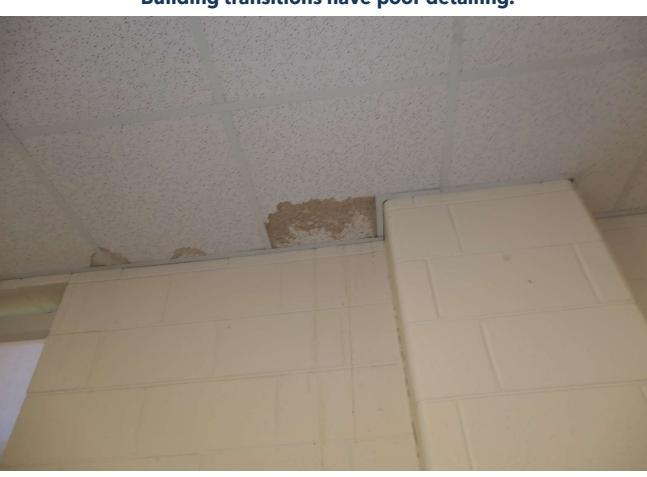
Stained sealing tile likely caused by roof leak.

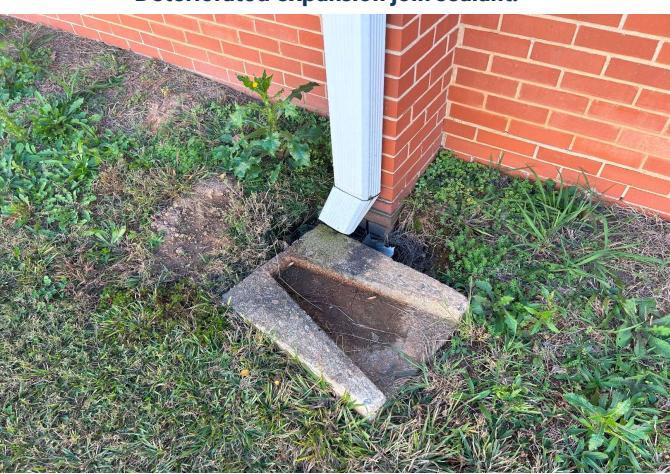
Downspouts don't direct water away from the building.

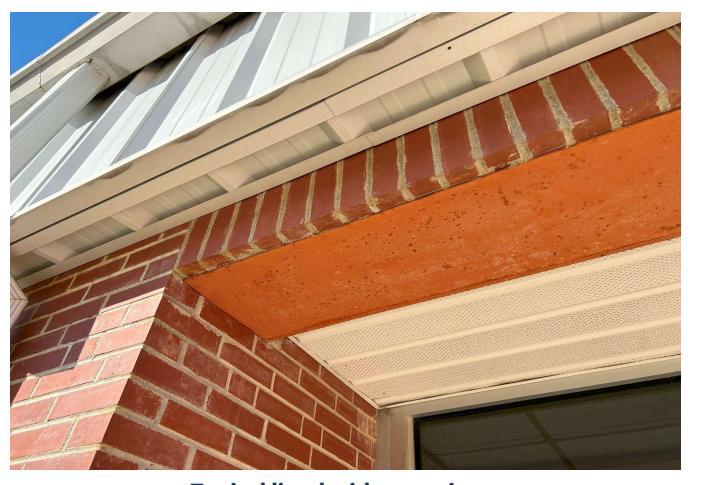
Typical lintel with corrosion.

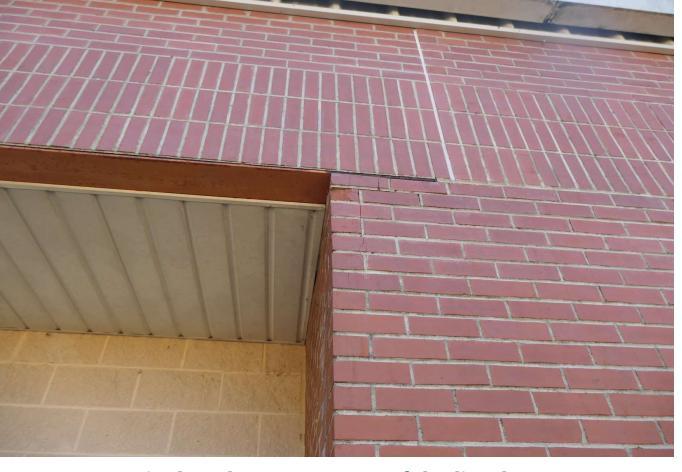
Displaced mortar at one of the lintels.

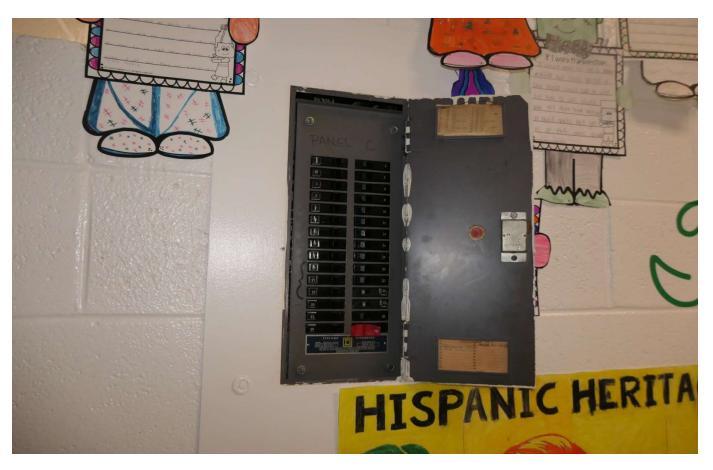
Vintage elctical panel which should be budgeted for replacement.

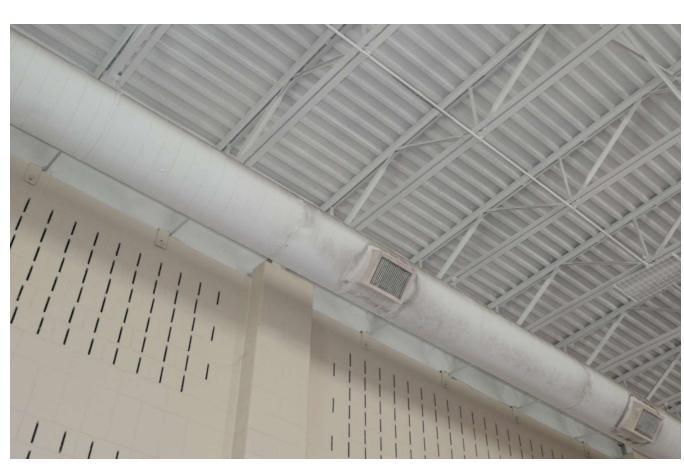
Dust/debris noted on the ductwork of the gymnasium.

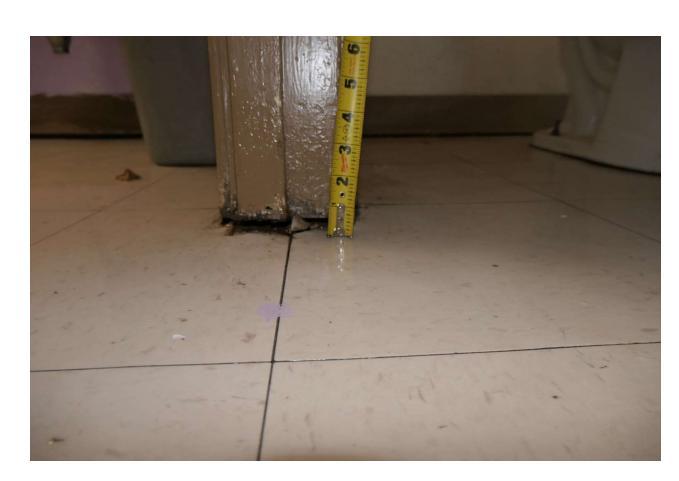
Settlement noted between the floor slab and door frame.

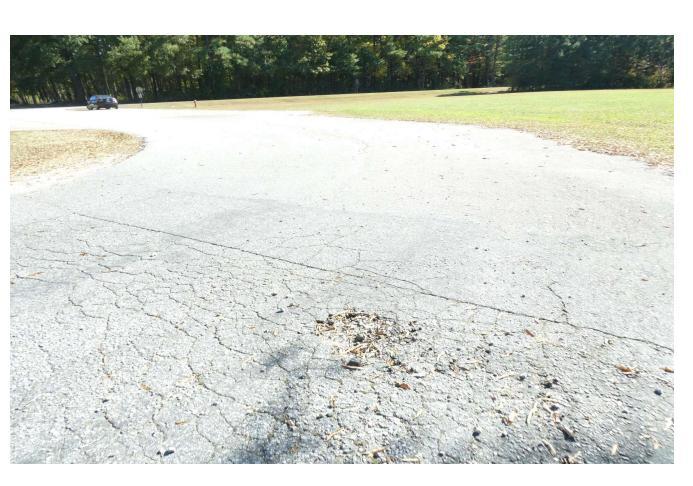
Typical condition of asphalt pavement with alligator cracking.

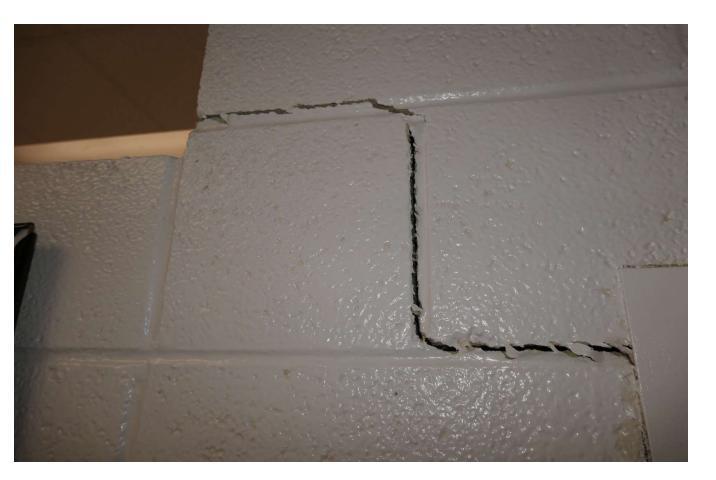
Interior step cracking of a CMU wall.

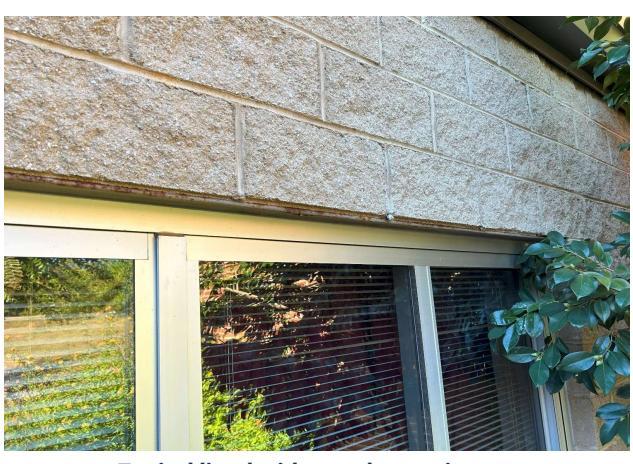
Typical lintel with noted corrosion.

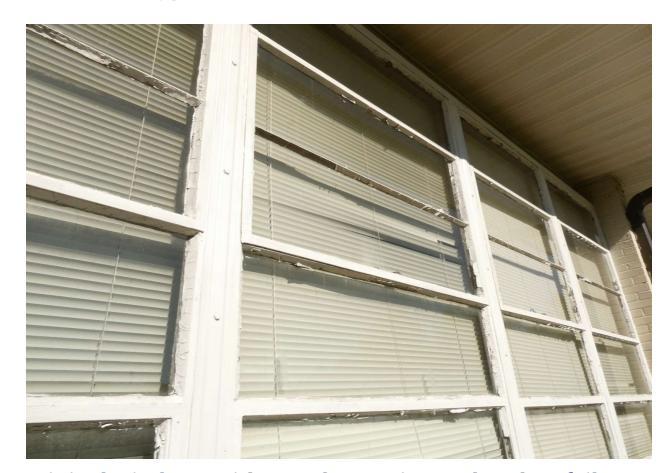
Original windows with noted corrosion and sealant failure.

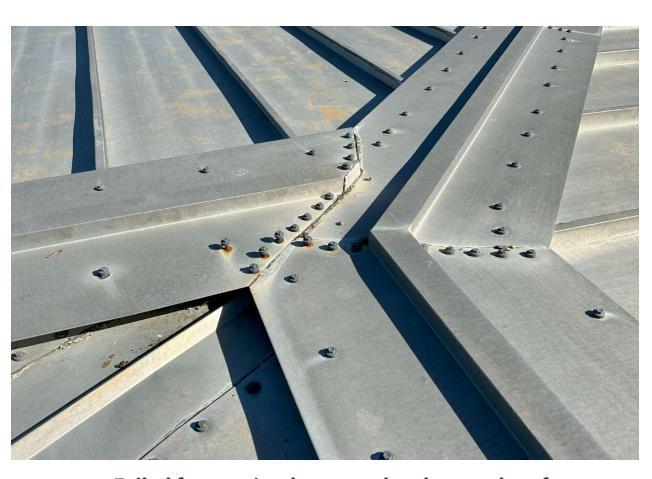
Failed fastners/gaskets noted at the metal roof.

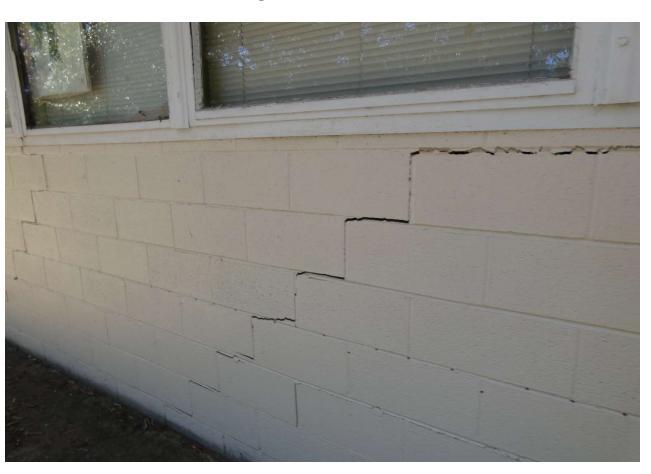
Exterior stair step cracking due to noted structural issues.

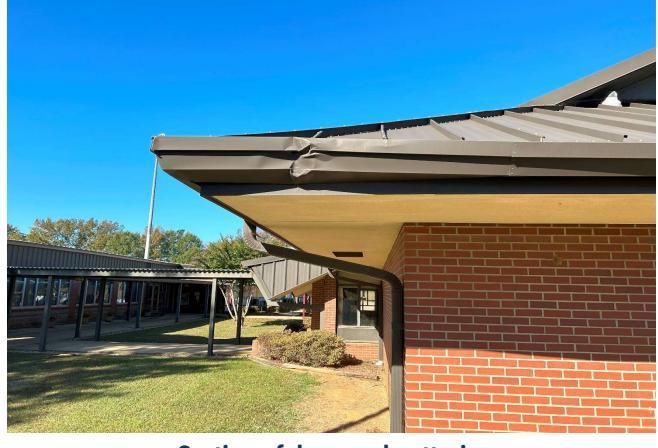
Section of damaged guttering.

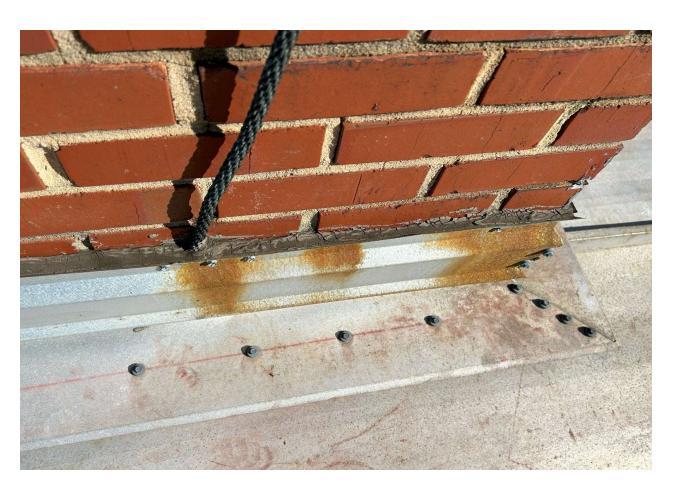
Failed sealants at termination bar.

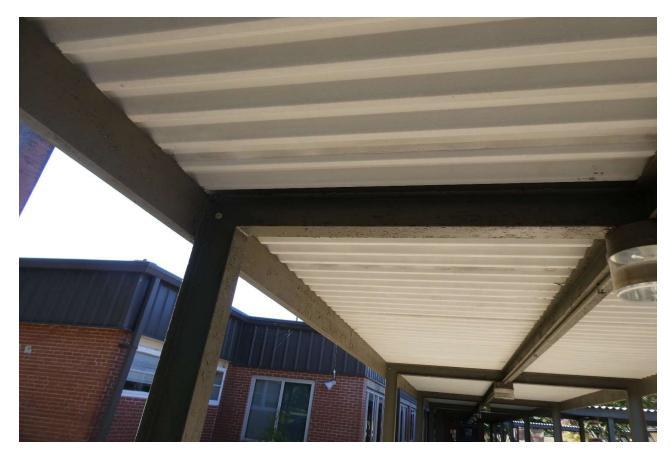
The framing for the covered walkway has evidence of historical corrosion which has been painted over.
