# School Closing Study

Mariam Boyd Elementary, Northside Elementary, and Vaughan Elementary schools

February 13, 2024

# FINANCIAL SUMMARY OF CONDITION ASSESSMENT FINDINGS

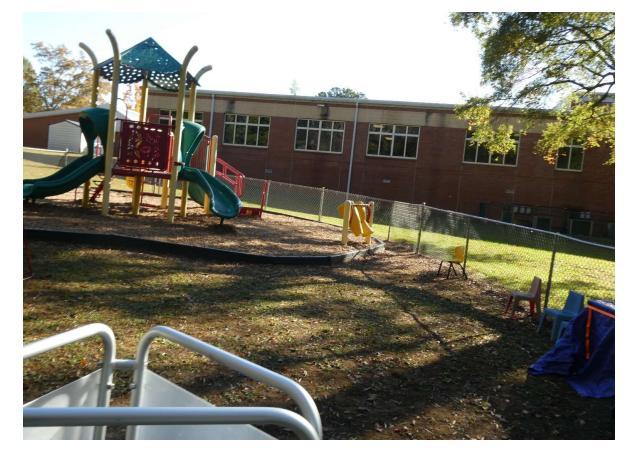
Playground and exterior façade on west side

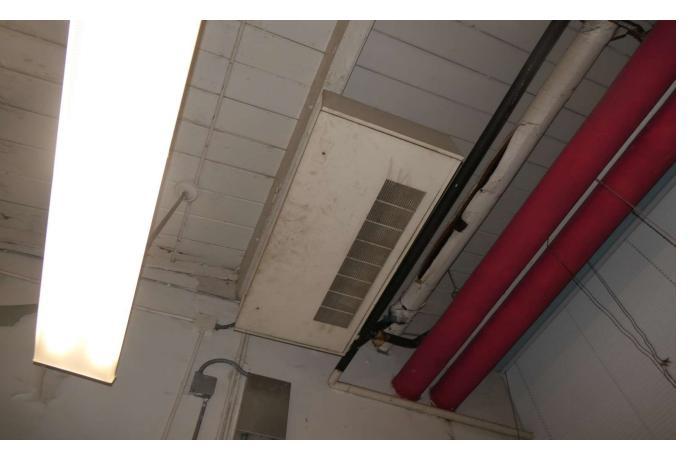
Typical unit ventilator in the original classrooms.

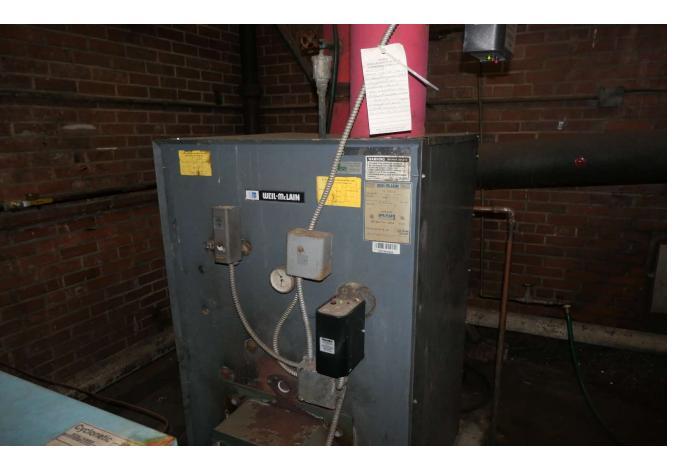
Typical heating hot water boiler.

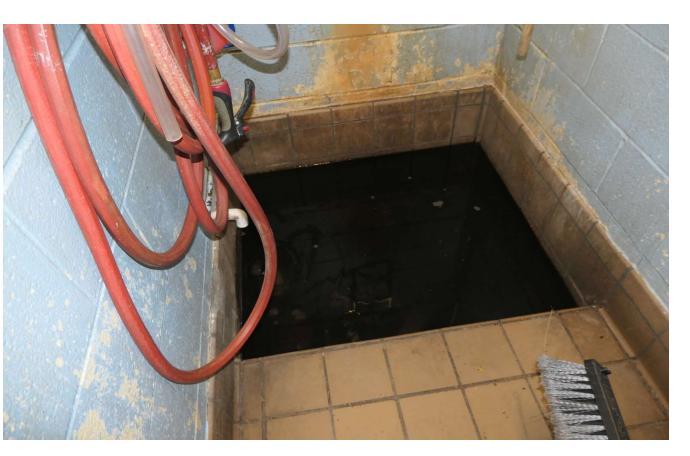
Clogged mop sink drain due to grease trap.

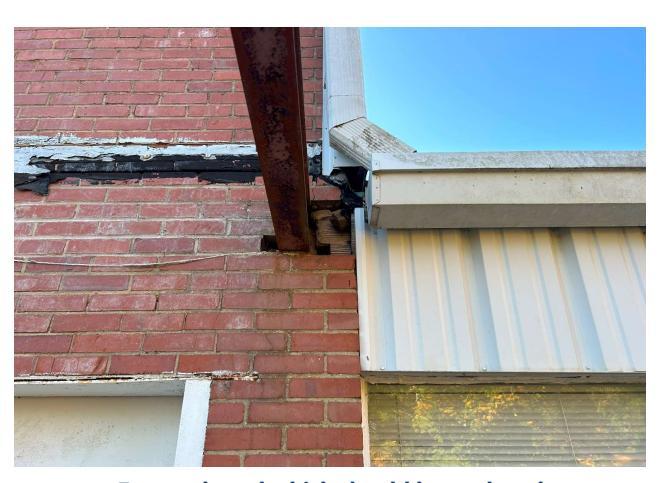
Exposed steel which should be enclosed.

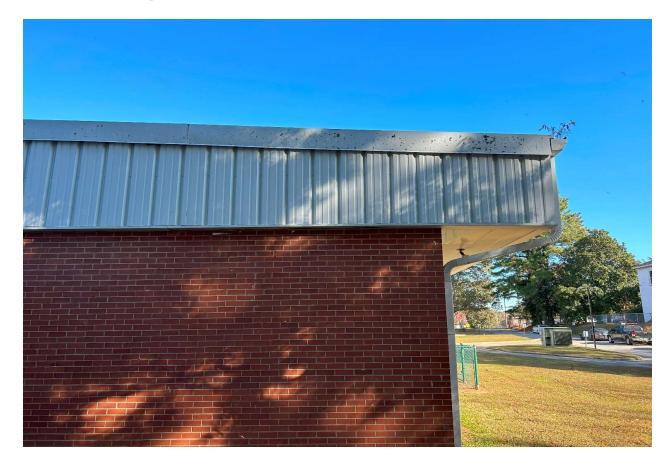
Organic growth on fascia panels.

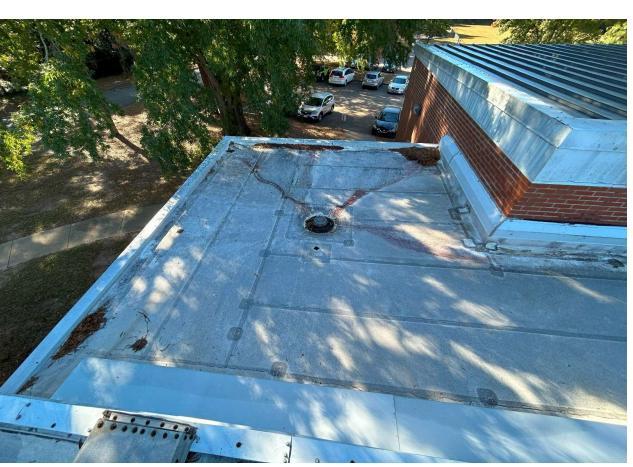
Overview of TPO roof covering.

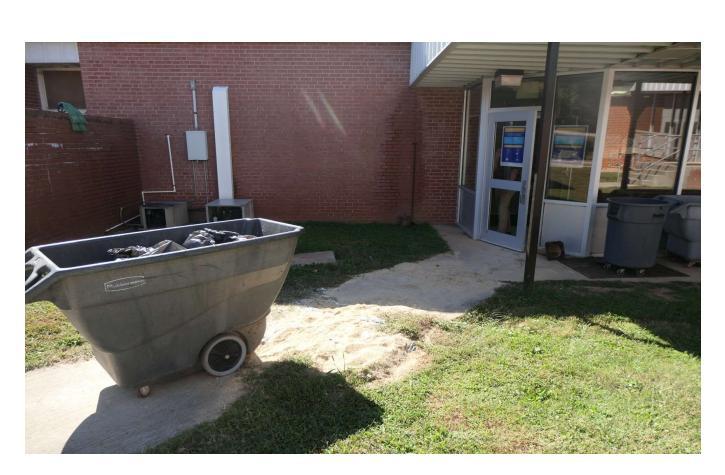
Area if poor drainage which enters into the building.

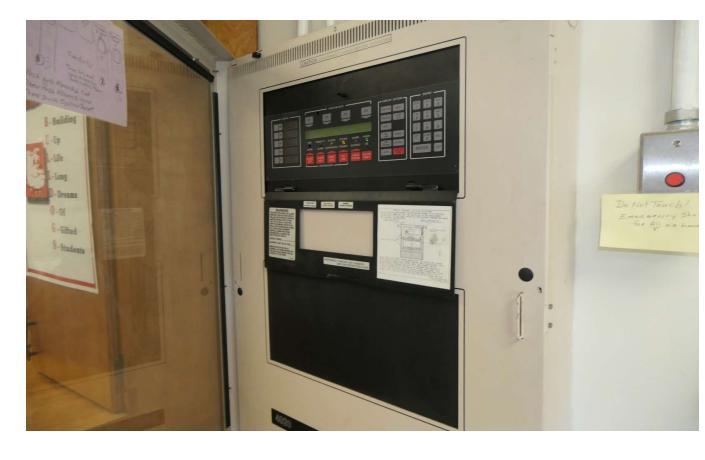
The fire detection and alarm system is obsolete.

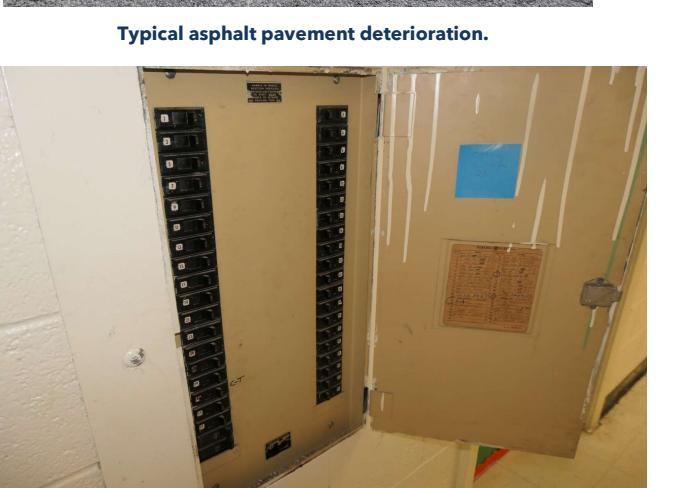
Typical obsolete electrical equipment.

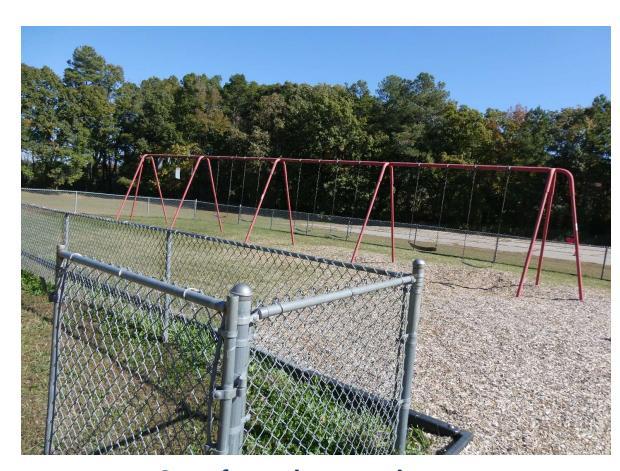
One of two playground areas.

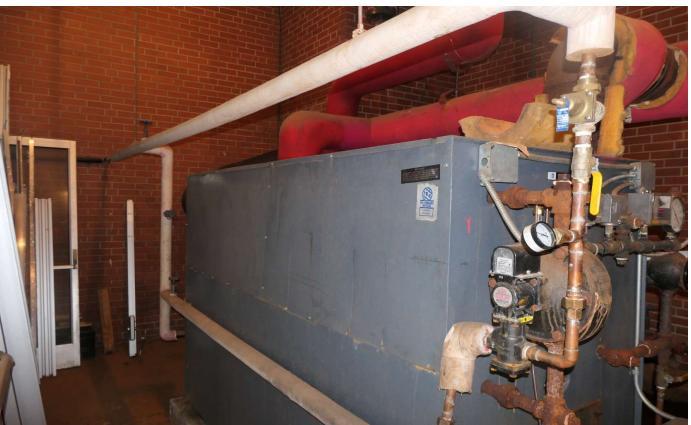
Steam boiler and heat exchanger for hydronic heating.

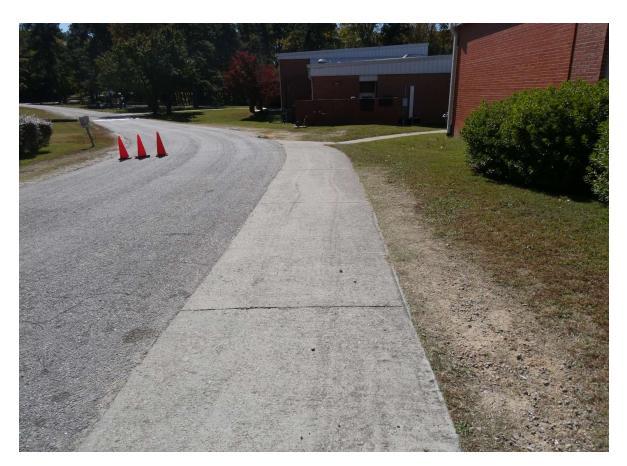
Typical concrete sidewalk sections.

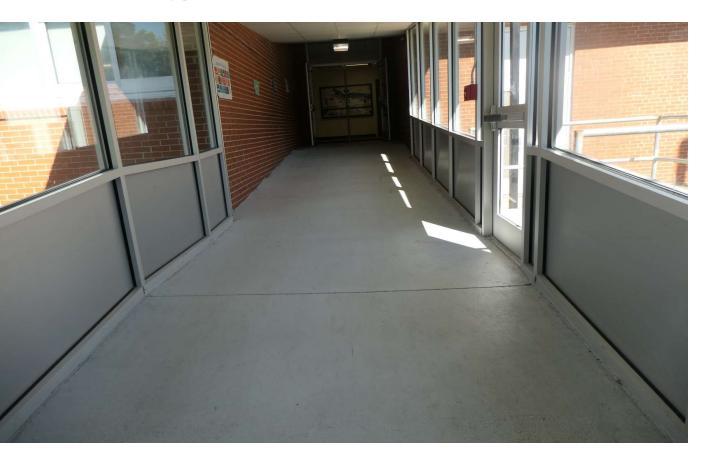
Handrails are not provided at the interior ramp connecting the buildings.

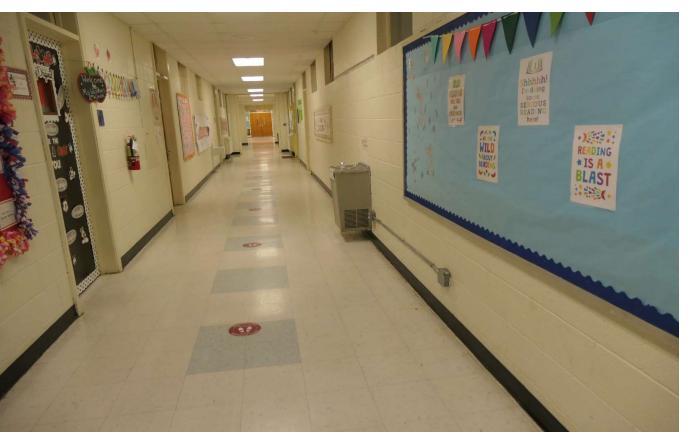
Additional emergency egress lighting is required throughout the building.

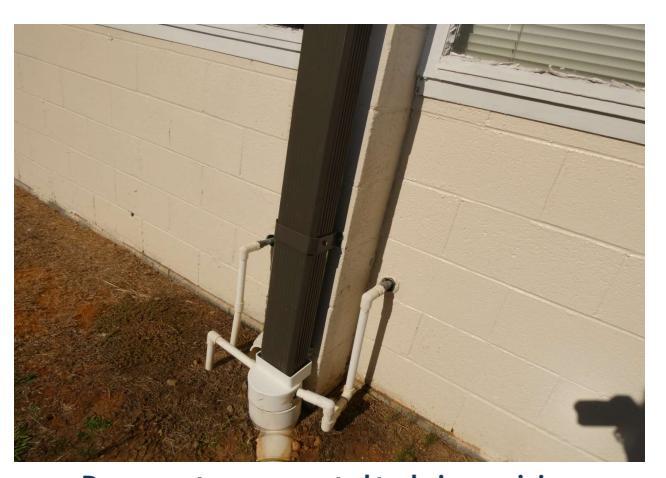
Section of damaged guttering.

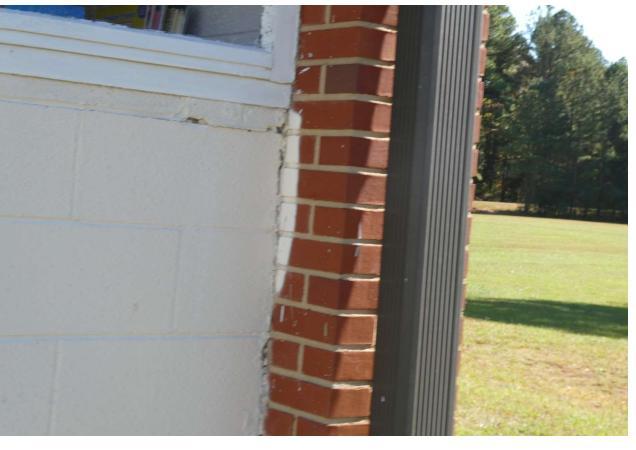
General condition of exterior sealants.
